# Removal of Biofouling / Marine Growth

### Heavy Marine Growth on Heat Exchangers

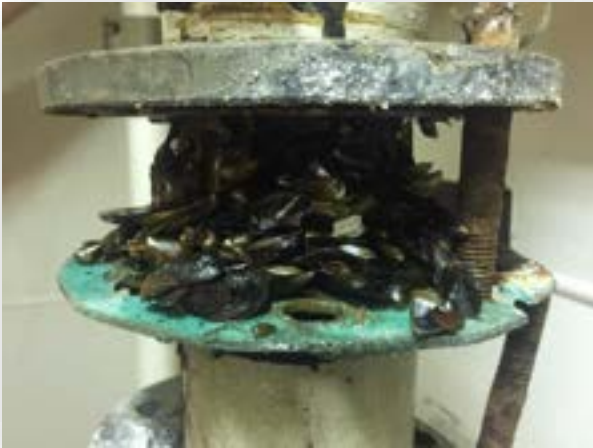
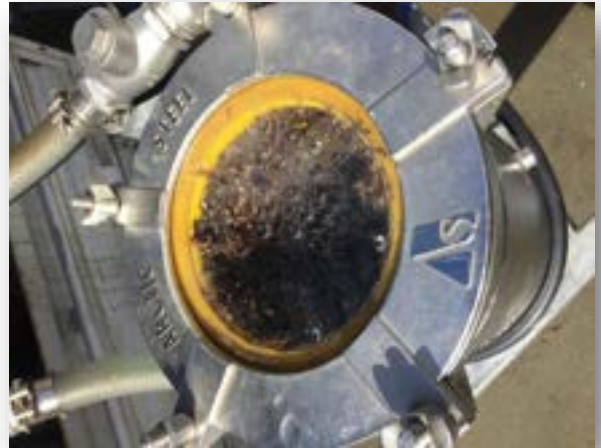
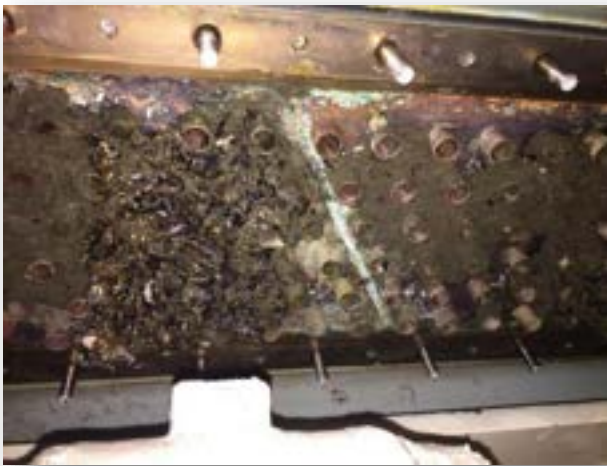
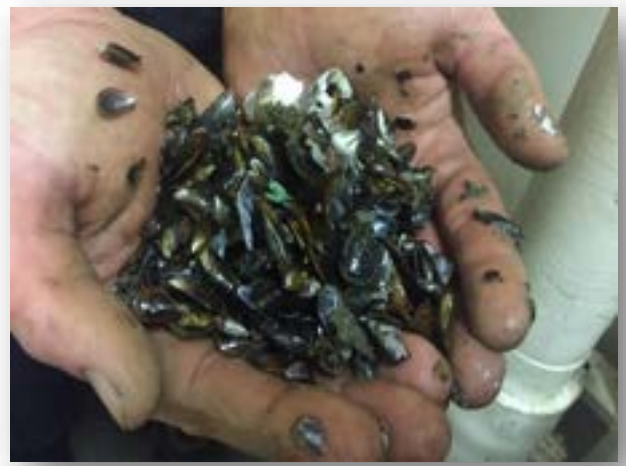
**The Problem:** There were blockages in the Machinery Space Ventilation Heat Exchangers and when the Heat Exchangers were inspected, the entire system was found to be choked with marine growth.

**The Heat Exchangers were literally blocked solid with marine growth.**

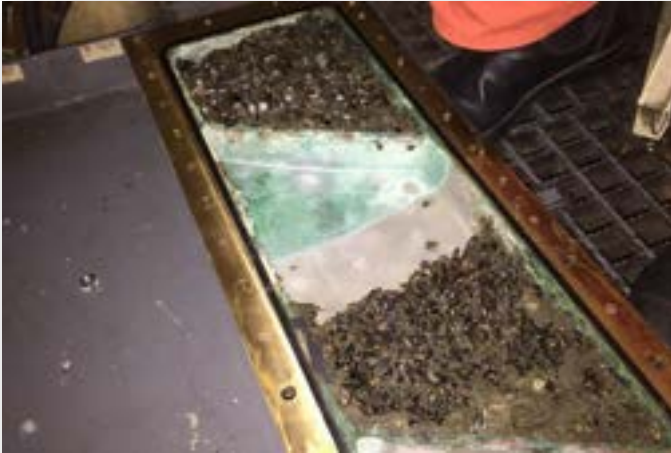
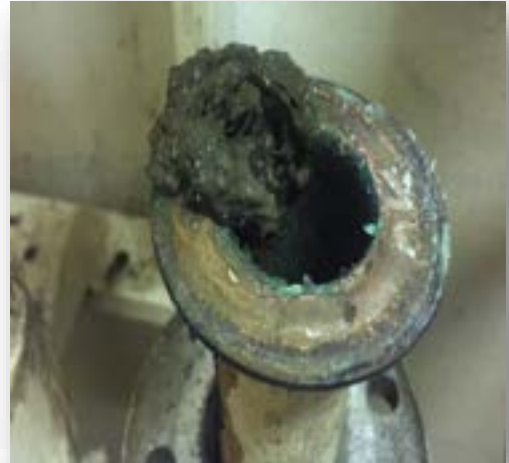
Triple7 EnviroScale was flushed through the system to remove the blockages.

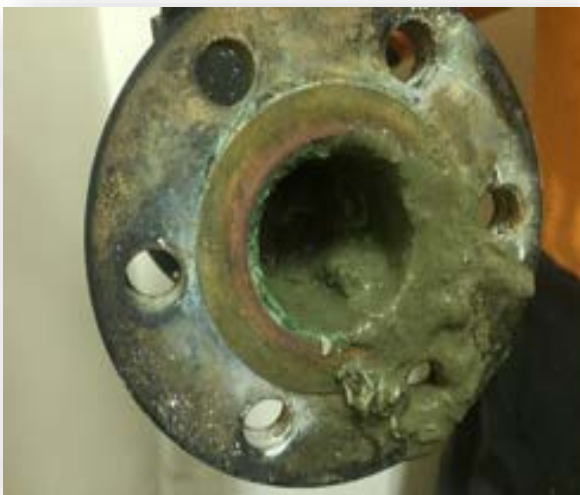
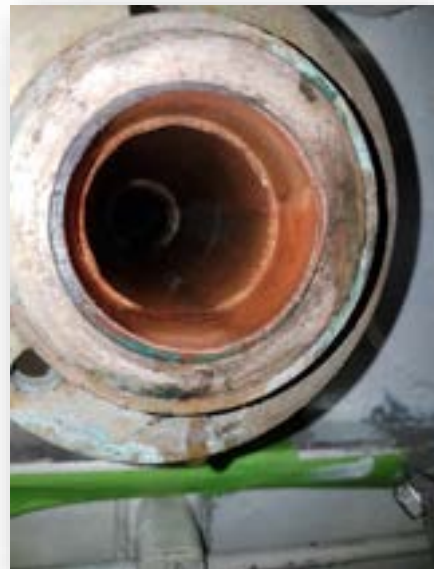
The pipework was inspected after the initial flush – Triple7 EnviroScale dissolved the growth and turned it in to a sludge that was being removed from the pipework.
